**Flood Control Project Maintenance
Levee Inspections**

Fall 2010 Levee Maintenance Deficiency Summary Report

Reclamation District No. 0999 Netherlands

Levee Inspection Report By Mile - Fall 2010

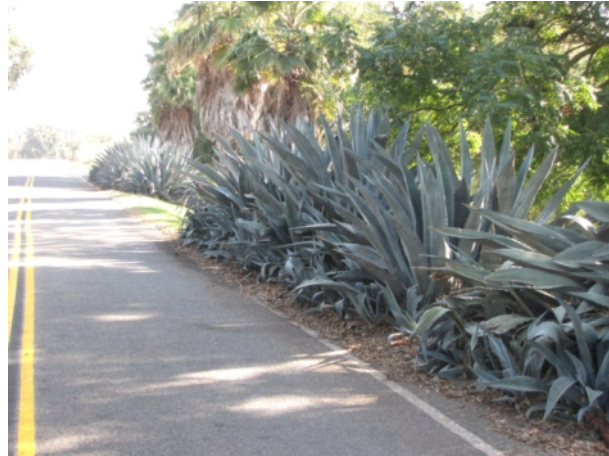
Levee Mile Report Line	1
Start Levee Mile	0.03
End Levee Mile	0.06
Location	Water Side
Category	Earthen Levee
Item	Encroachments
Looking north at century plant on landside shoulder.	
richard_f_20101021_331.jpg

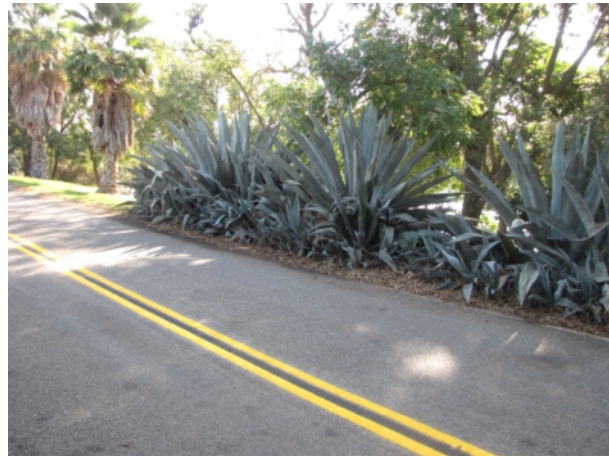
Levee Mile Report Line	1
Start Levee Mile	0.03
End Levee Mile	0.06
Location	Water Side
Category	Earthen Levee
Item	Encroachments
Looking east at century plant on landside shoulder.	
richard_f_20101021_332.jpg

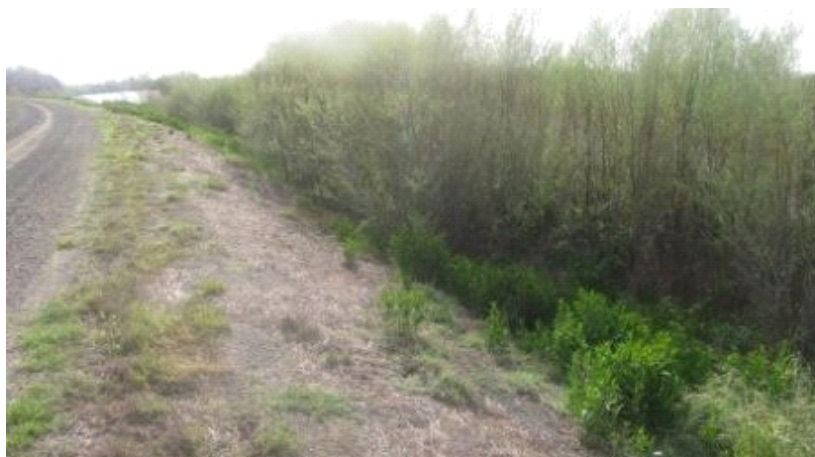
Levee Mile Report Line	9
Start Levee Mile	1.09
End Levee Mile	1.13
Location	Water Side
Category	Earthen Levee
Item	Trim / Thin Trees
Looking northeast at dense veg. on waterside slope.	
richard_f_20100921_251.jpg

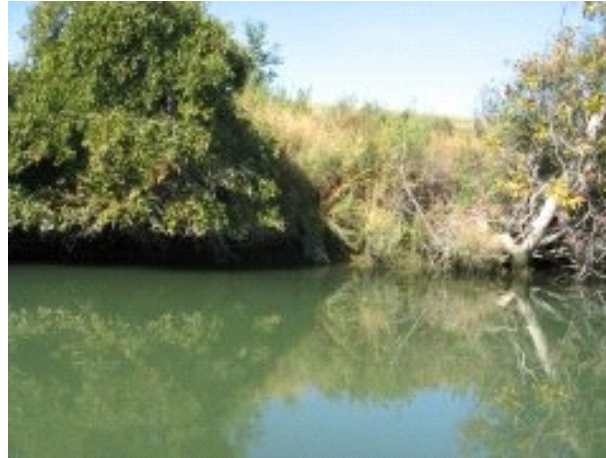
Levee Mile Report Line	4
Start Levee Mile	0.22
End Levee Mile	0.63
Location	Water Side
Category	Supplemental
Item	USACE Erosion Survey
2009: 5 ft berm, 1.5:1 slope, tree hazards and holes, clays and silts, 4.73 ft/s [2009 SiteID:STR_24-7_R]	
richard_f_20100921_271.JPG

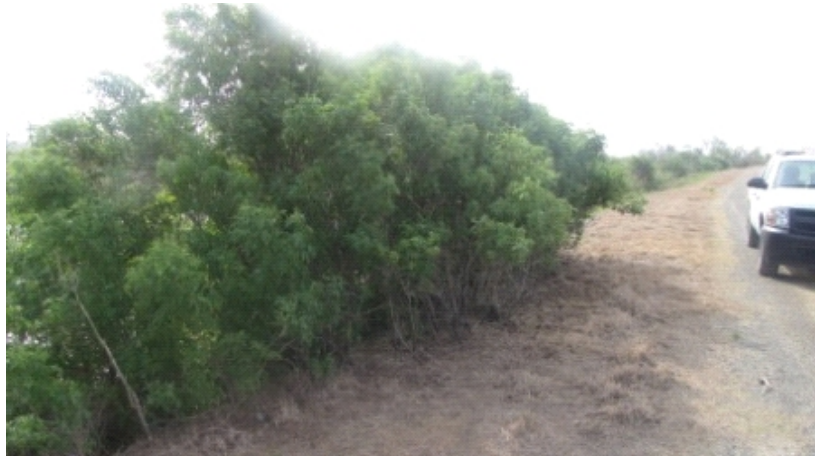
Levee Mile Report Line	5
Start Levee Mile	0.44
End Levee Mile	0.44
Location	Water Side
Category	Earthen Levee
Item	Vegetation
Looking southwest at elderberry bush on waterside slope.	
richard_f_20100921_262.jpg

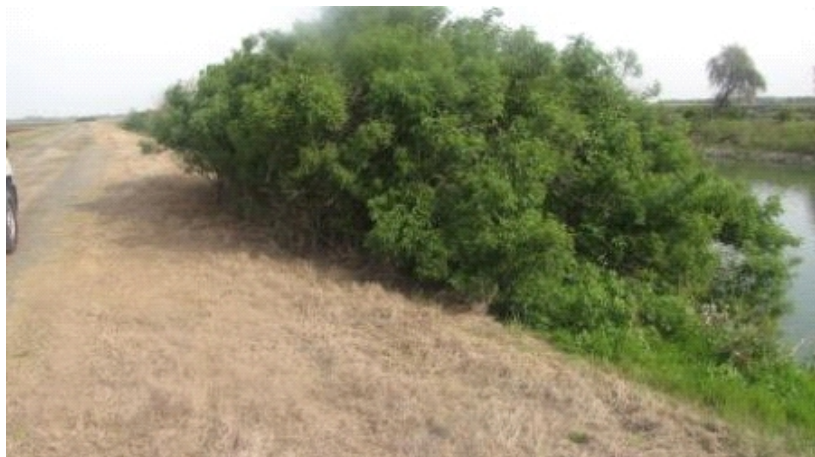
Levee Mile Report Line	5
Start Levee Mile	0.44
End Levee Mile	0.44
Location	Water Side
Category	Earthen Levee
Item	Vegetation
Looking north at elderberry bush on waterside slope.	
richard_f_20100921_263.jpg

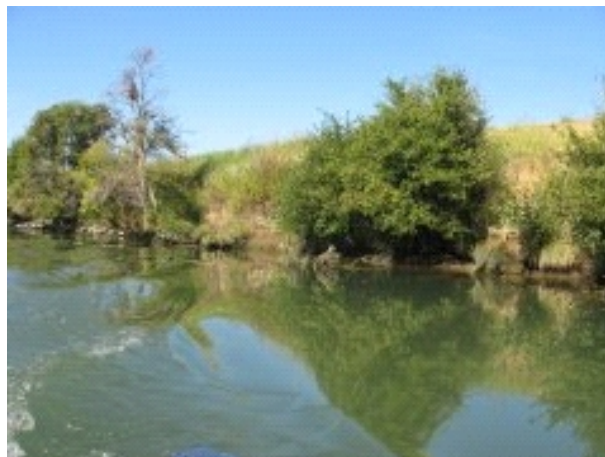
Levee Mile Report Line	13
Start Levee Mile	0.96
End Levee Mile	1.10
Location	Water Side
Category	Supplemental
Item	USACE Erosion Survey

2009: no berm, 1:1 slope, tree hazards, clays and silts, 4.64 ft/s [2009 SiteID:STR_25-2_R]

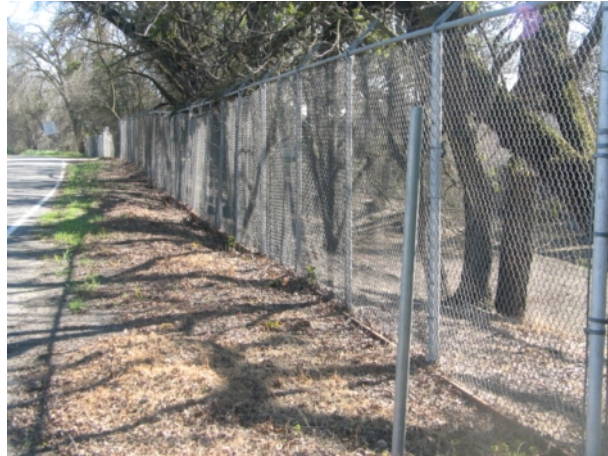
Levee Mile Report Line	2
Start Levee Mile	0.05
End Levee Mile	0.11
Location	Land Side
Category	Earthen Levee
Item	Encroachments
Cyclone fence along landside shoulder at LM 0.05 -0.11	
richard_f_20100921_275.jpg

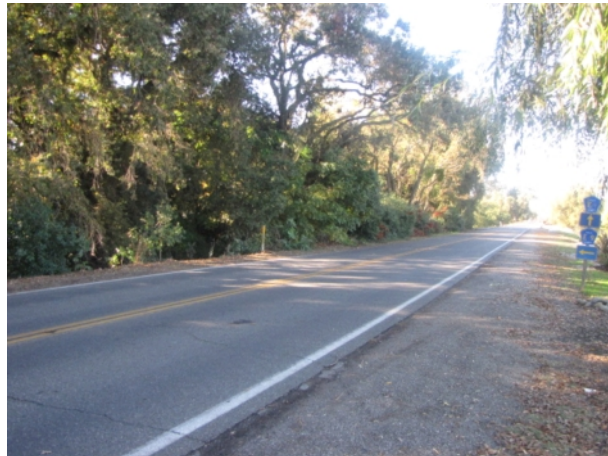
Levee Mile Report Line	4
Start Levee Mile	0.31
End Levee Mile	0.35
Location	Land Side
Category	Earthen Levee
Item	Encroachments
Looking northwest at dense veg on landside shoulder and slope.	
richard_f_20101110_383.jpg

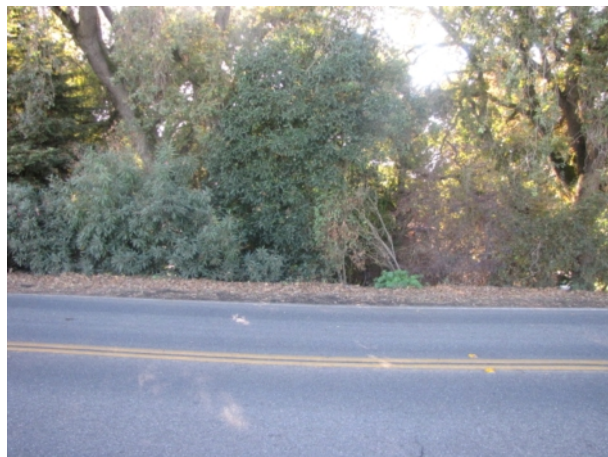
Levee Mile Report Line	4
Start Levee Mile	0.31
End Levee Mile	0.35
Location	Land Side
Category	Earthen Levee
Item	Encroachments
Looking west at dense veg on landside slope and toe.	
richard_f_20101110_384.jpg

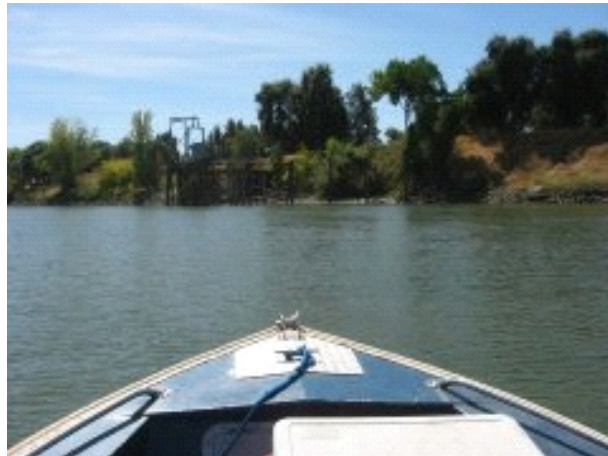
Levee Mile Report Line	14
Start Levee Mile	0.80
End Levee Mile	0.84
Location	Water Side
Category	Supplemental
Item	USACE Erosion Survey
2009: no berm, 1.5:1 slope, tree hazards and slumping, sands and silts, 5.36 ft/s [2009 SiteID:SAC_42-7_R]	
richard_f_20100921_276.JPG

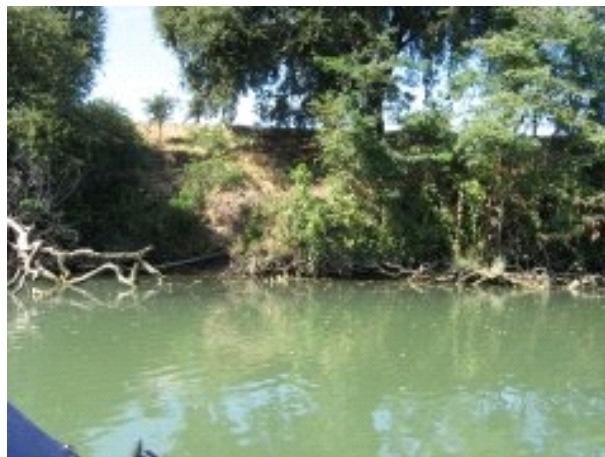
Levee Mile Report Line	3
Start Levee Mile	0.24
End Levee Mile	0.26
Location	Water Side
Category	Supplemental
Item	USACE Erosion Survey

2009: no berm, 1:1 slope, tree hazards, clays and cobbles, 3 ft/s [2009 SiteID:ELK_0-2_R]

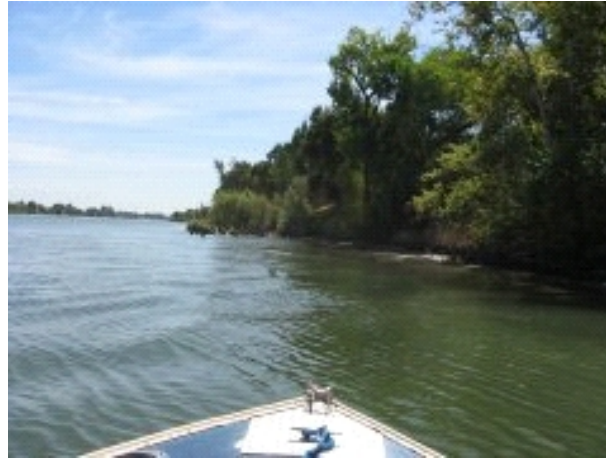
Levee Mile Report Line	4
Start Levee Mile	0.26
End Levee Mile	9.66
Location	Water Side
Category	Supplemental
Item	USACE Erosion Survey
2009: no berm, 1.5:1 slope, tree hazards and holes, sands and silts, 5.08 ft/s [2009 SiteID:SAC_41-9_R]	
richard_f_20100921_302.JPG

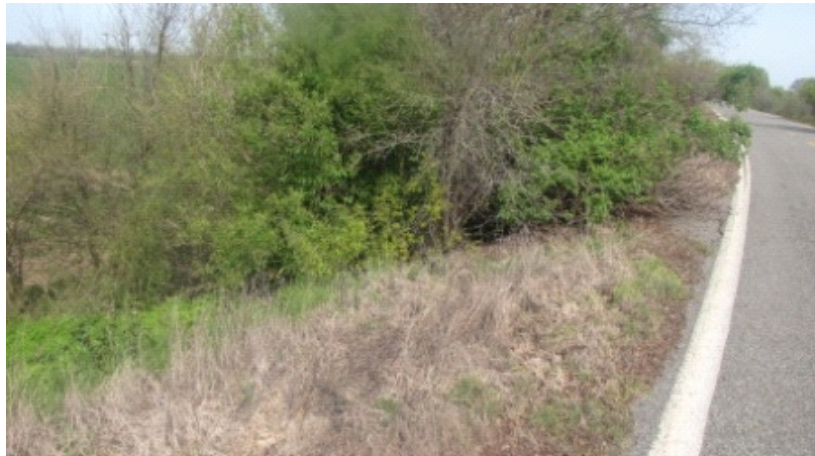
Levee Mile Report Line	7
Start Levee Mile	0.40
End Levee Mile	0.40
Location	Land Side
Category	Earthen Levee
Item	Trim / Thin Trees
Looking north at dense veg. on landside slope and toe.	
richard_f_20100921_279.jpg

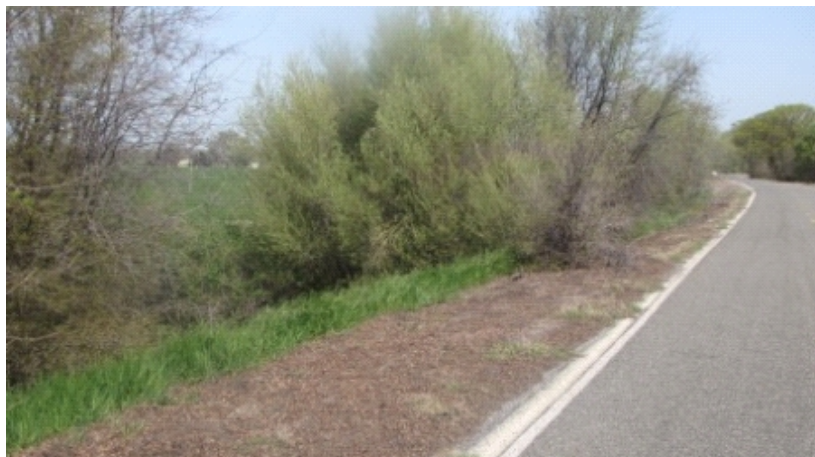
Levee Mile Report Line	10
Start Levee Mile	0.43
End Levee Mile	0.47
Location	Land Side
Category	Earthen Levee
Item	Trim / Thin Trees
Looking north at dense veg. on landside slope and toe.	
richard_f_20100921_286.jpg

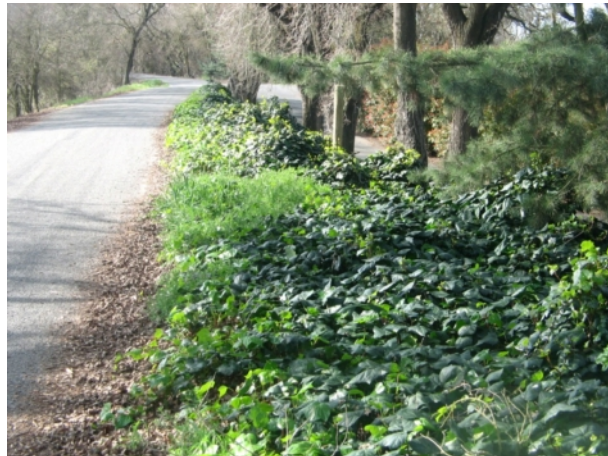
Levee Mile Report Line	17
Start Levee Mile	0.84
End Levee Mile	0.94
Location	Land Side
Category	Earthen Levee
Item	Encroachments
View of landscaping (Ivy) looking upstream from LM 0.84 to 0.94	
richard_f_20100921_282.jpg

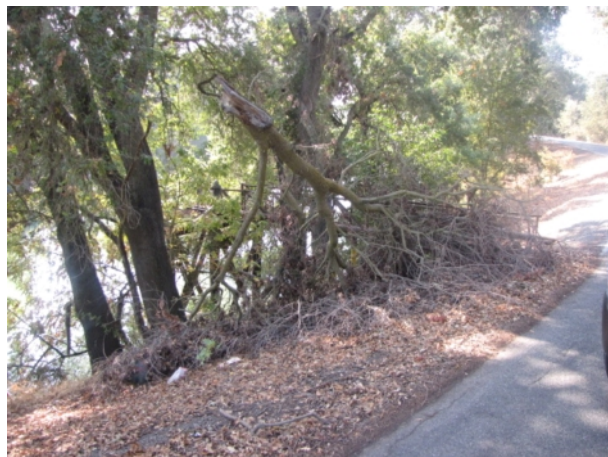
Levee Mile Report Line	20
Start Levee Mile	1.17
End Levee Mile	1.17
Location	Water Side
Category	Earthen Levee
Item	Encroachments
Looking southeast at fallen limb on waterside slope and shoulder.	
richard_f_20101021_342.jpg
